IIB05-1-S

## INSTALLATION BULLETIN

**SUBJECT:** Home Standby Air-cooled Generators - Serial Numbers 3789827 and Below

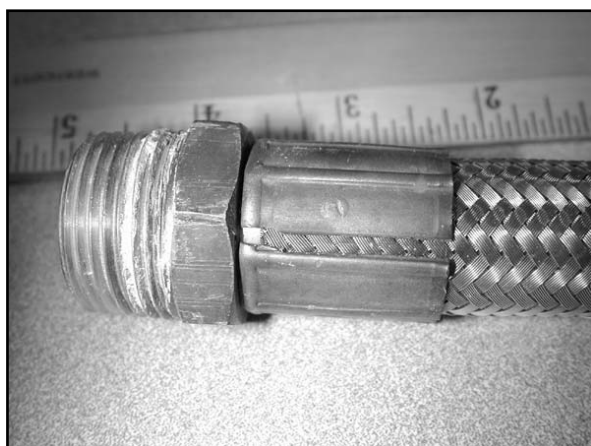
**Figure 1**

**CAUTION:** The 12" braided flex fuel line supplied with the subject generators can leak if improperly installed.

Split Ferrule On 12" Braided Flex Fuel Line

The flex fuel line must not be bent beyond 10 degrees during the installation and upon completion of installation. Replace the fuel line if bent or if ferrules are damaged. The replacement fuel line is Part # 0D3031A. Ensure the installation of the new fuel line eliminates bends.

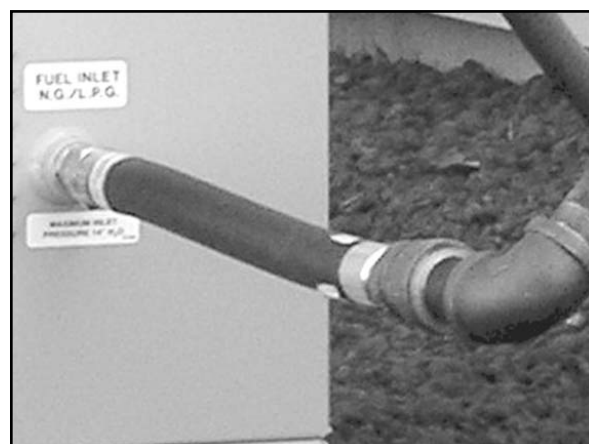
**Figure 2**

Proper Installation Of New Flex Fuel Line Without Bends

**CAUTION:** Turn off gas supply before replacing flex fuel line and check for leaks after installation of new flex fuel line.
